Case Study

BAE SYSTEMS

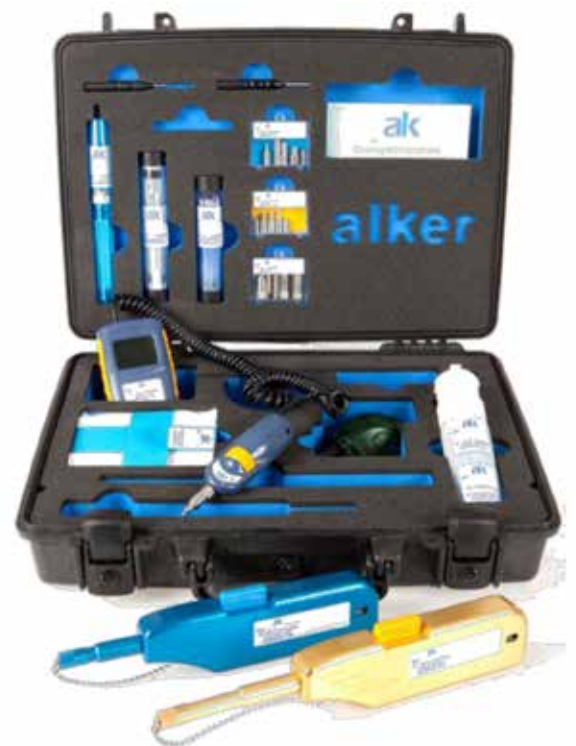
- Microscope to inspect termini end faces for debris or damage
- Can be used with both singlemode and multimode fibres
- Designed for military multiway ferrule connectors
- No need to remove termini/ferrule from connector, saving time and minimising the risk of damage
- Prototypes manufactured, tested approved and ordered for multiple kits in use across Saudi Arabia with stock holding agreement for immediate shipping worldwide
- Angled cleaning available for difficult to reach places, designed to clean fibre optic patchcords pigtailed and adapters of all types.
